## 5. PLASTIRA STREET

### 5.1. Case Study Area and Character Sections

Plastira street is located in the Eastern part of the city of Kalamaria and it is a significant two-way arterial street. Its total length is approximately 2,800m, while the Case Study segment is 1,120m long.

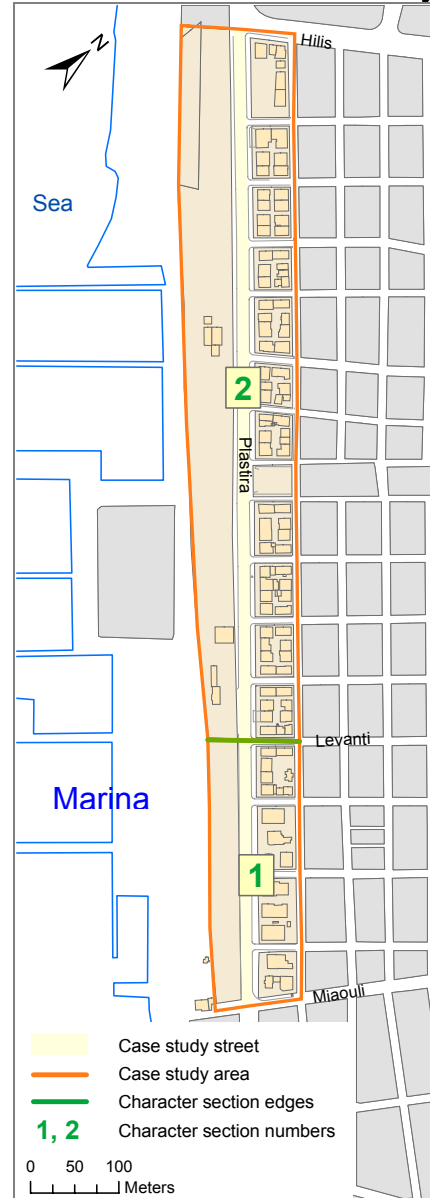
For the purpose of the project, Plastira Street Study Area was divided into two Character Sections.

Section 1, as shown in the map, runs between Miaouli and Levanti Street (300m). The predominant land use of this section is recreation at the ground and first floors, and residence on the upper floors, but only at the eastern side of the road. The western side – the one close to the coast – is used as cafeteria open space and as entry points to the marina.

Section 2 starts from Levanti Street up to Hilis Street (820m) and has a more or less residential character.

Character sections of Case study

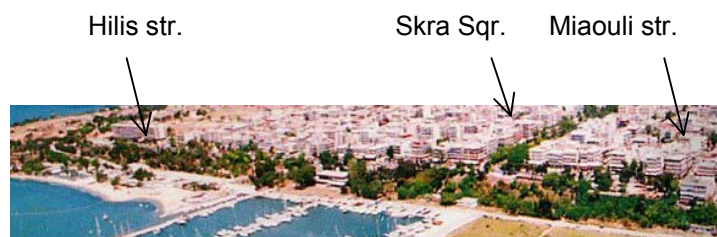
**Trees and Other Greenery :** Green space of Plastira street shapes the street space and is an important formative element of the street, although it is not equally distributed in both street sides.

There is a large green area between the street and the sea, on the top of the slope, parallel to the street, as well as at the sea level (the latter does not influence the visual environment of the street). There are many trees, mostly pines.

*Plastira park – greenery in Section 1*

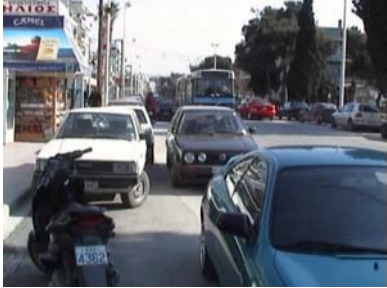
<p><i>Illegally parked cars next to legal parking spaces in Section 2. (note that bus on the background is the only moving vehicle on the frame)</i></p>

Signal Junctions :	<p>There are 6 signalised junctions in Plastira street study area. Three pedestrian crossings are provided in each signalised junction.</p>	
Roundabout Junctions :	<p>Plastira Street has no roundabout junctions.</p>	
Other Junctions :	<p>Plastira Street has 11 non-signalised (priority) junctions. Pedestrian crossings with zebra markings are not provided at these junctions.</p>	
On-Street Parking :	<p>Along the study area there are 310 on-street legal parking spaces.</p> <p>On street parking is permitted in both directions of the street. There are no restrictions and no special reserved parking spaces.</p> <p>During the evening hours, cars are parked in a second row, illegally, blocking the traffic lane, especially in Section 2. Most of them belong to visitors of the recreational land uses. Traffic Police of Kalamaria makes occasional attempts to control illegal parking, but enforcement is rather poor.</p>

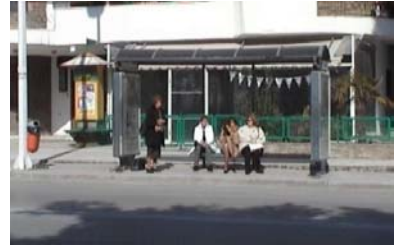
Bus stops on Plastira street are well marked and all of them - except one - provide shelter with a bench. Parking in front of bus stops to a length of 25m is prohibited by greek regulations. Drivers often violate this rule, and in addition there is poor enforcement.

*Typical bus stop with shelter in Section 1*

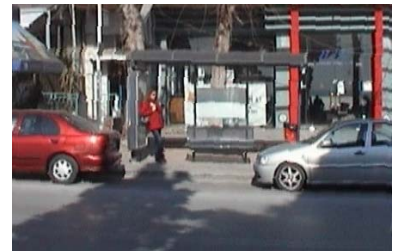
*Typical bus stop with shelter in Section 2 & illegally parked cars*

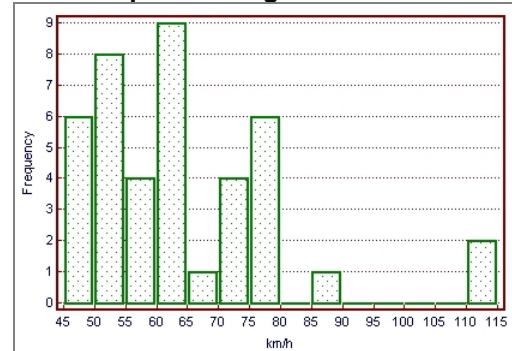
Vehicle Speed: Average speed of motorised vehicles in km/h (free flow conditions)  
64-Total str 56-Section 1 72-Section 2

V85 of motorised vehicles in km/h  
76-Total str 62-Section 1 78-Section 2

In free flow conditions drivers exceed speed limit in both sections.

**Vehicle speed histogram**
